Enriching the Lives of the Citizens through Waterfront Development

at The 10th Plenary Meeting of ANMC21

The Project of the Bang Khun Tien Coastal Erosion Protection and Prevention, Bangkok

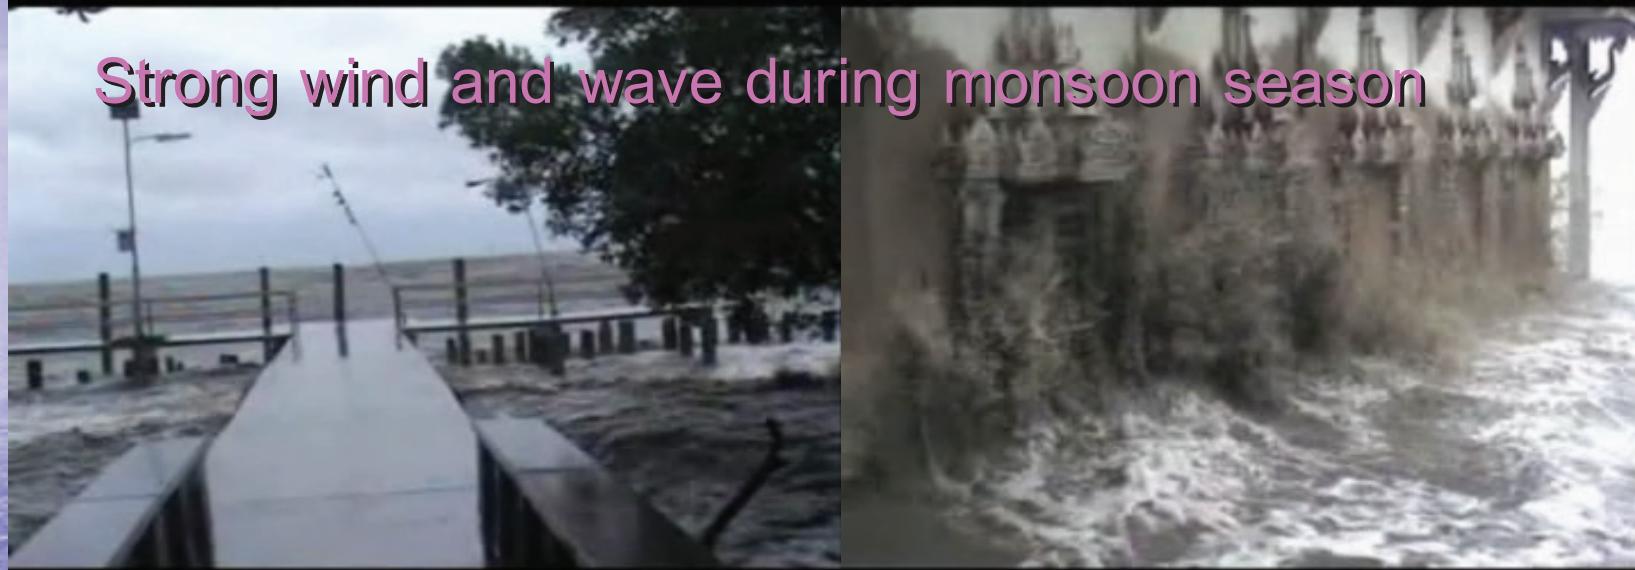
General condition of wind and wave in the upper Gulf of Thailand

Strong wind and wave during monsoon season

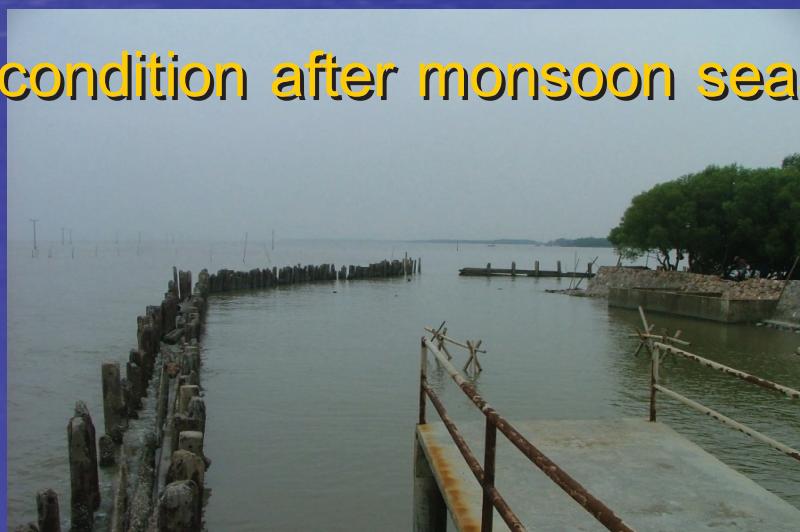
The condition after monsoon season

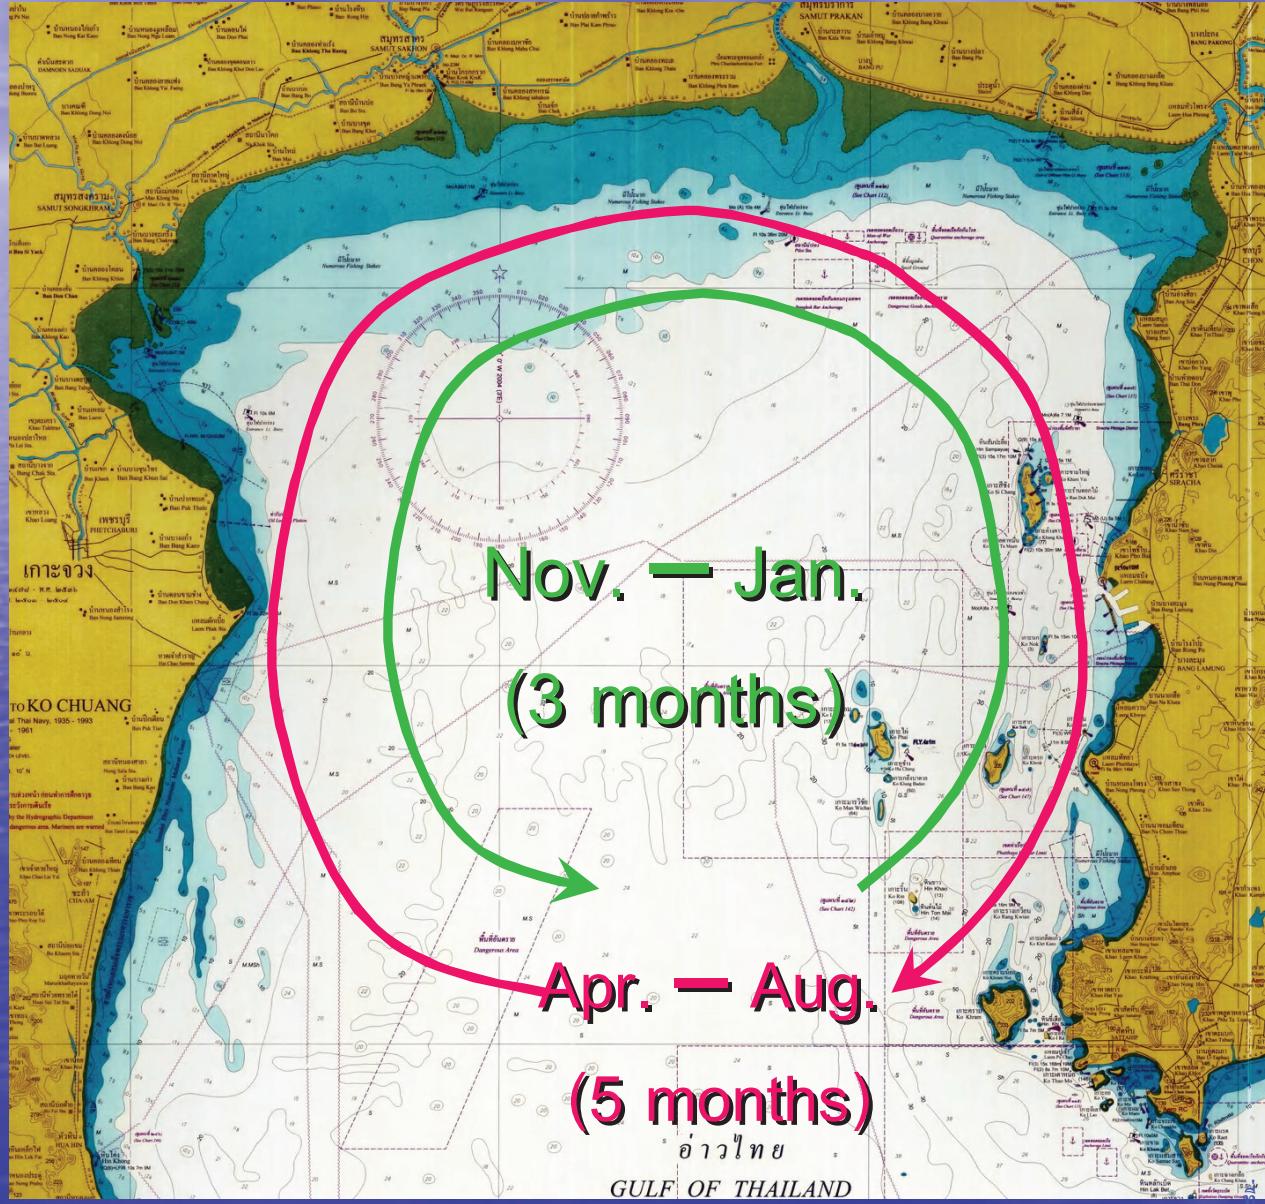
Current stream in the upper Gulf of Thailand

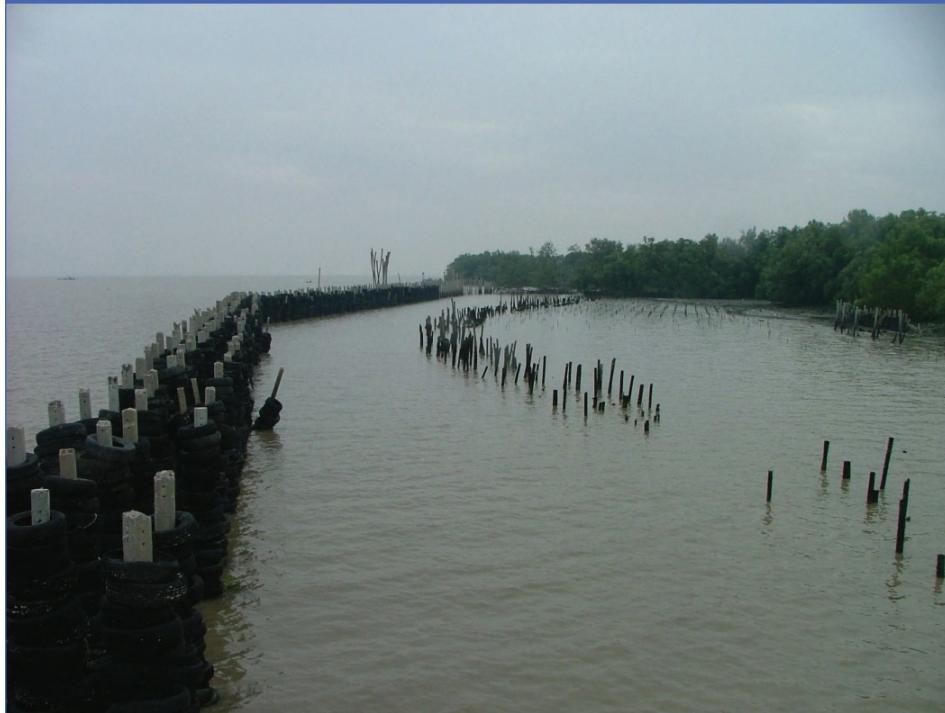
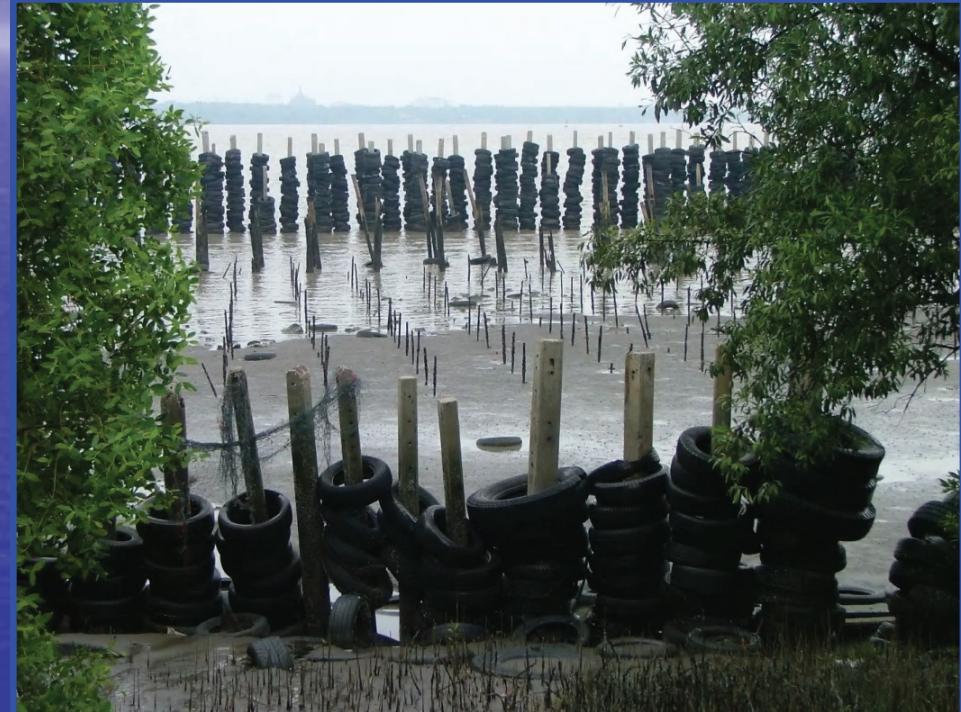
Piles of wheels to weaken the waves.

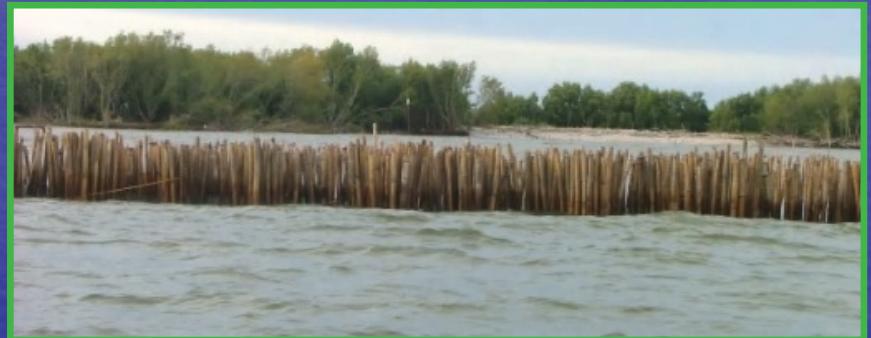
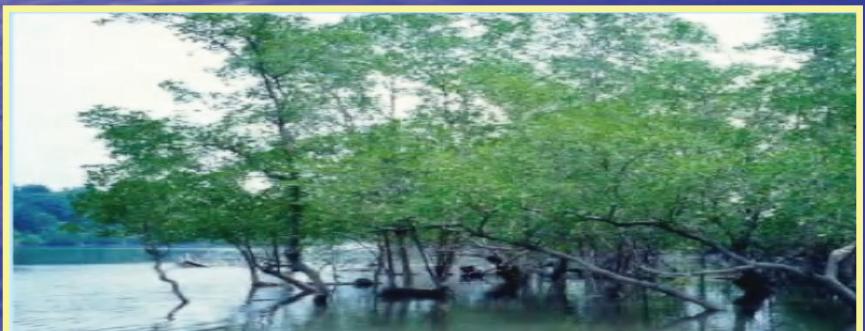
1. Hard (Permanent) measure :
Construction of sediment traps (T-Groins)

2. Temporary measure : bamboo piling
to protect coastal erosion
3. Soft measure : Mangrove plantation
(Mangrove Belt / Buffer Zone)

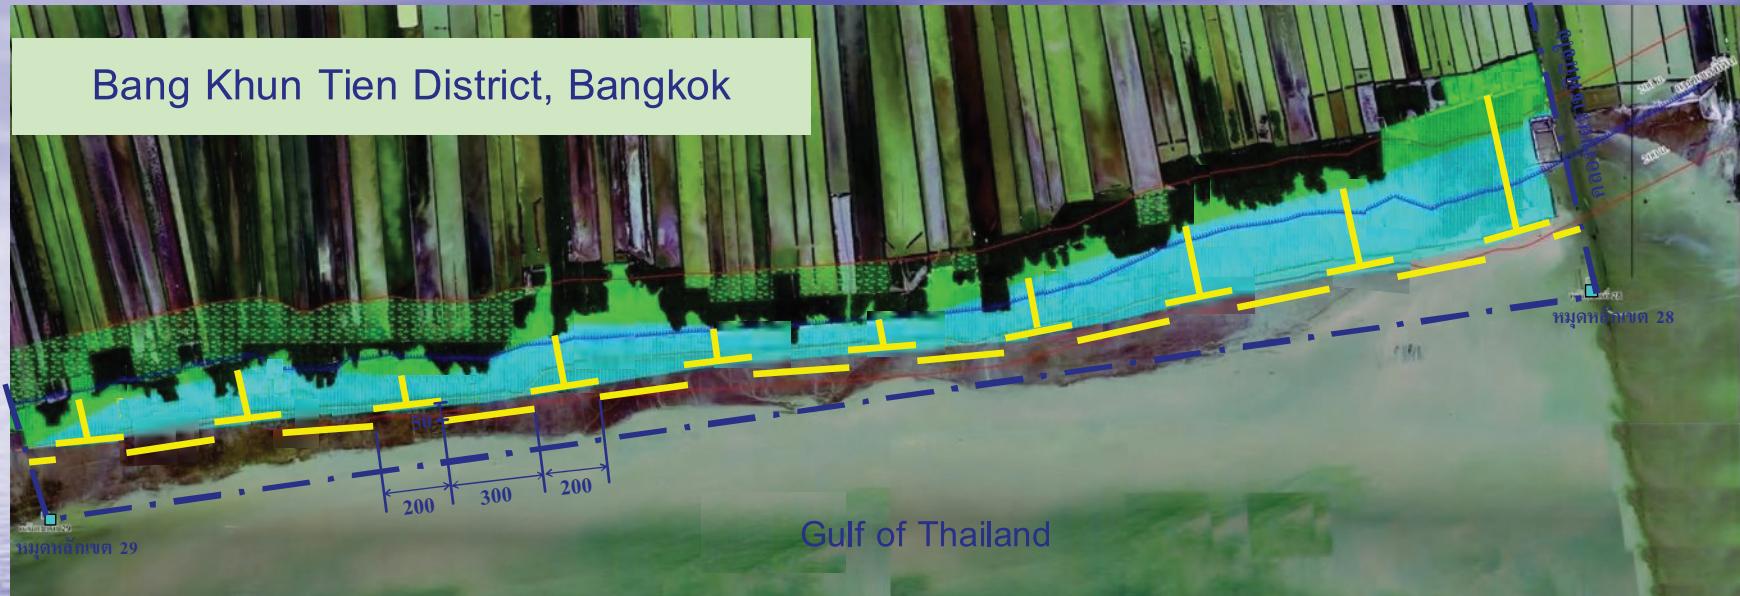
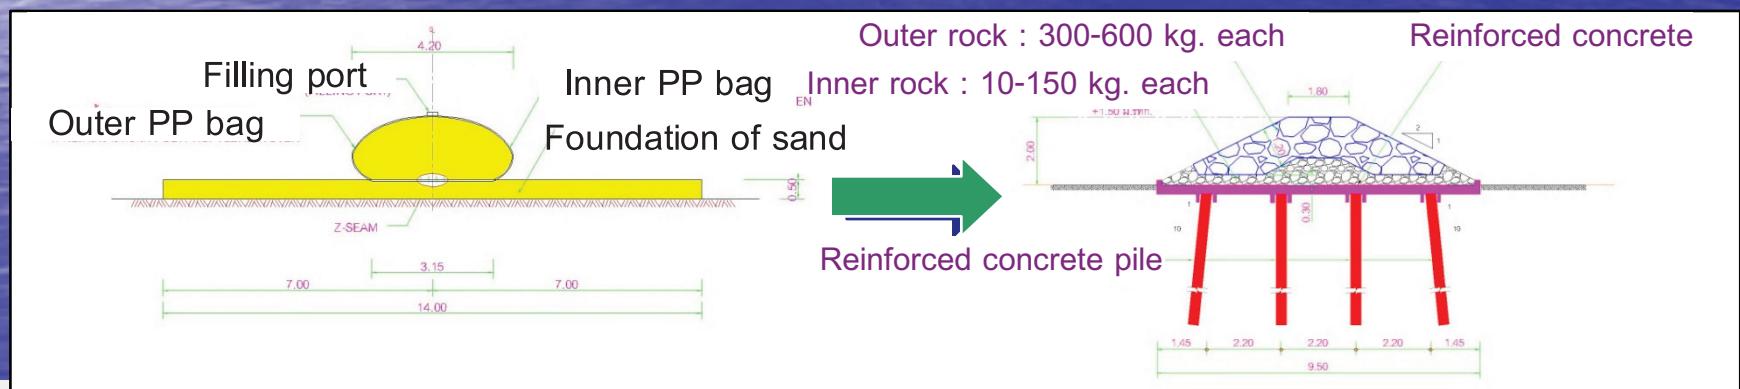
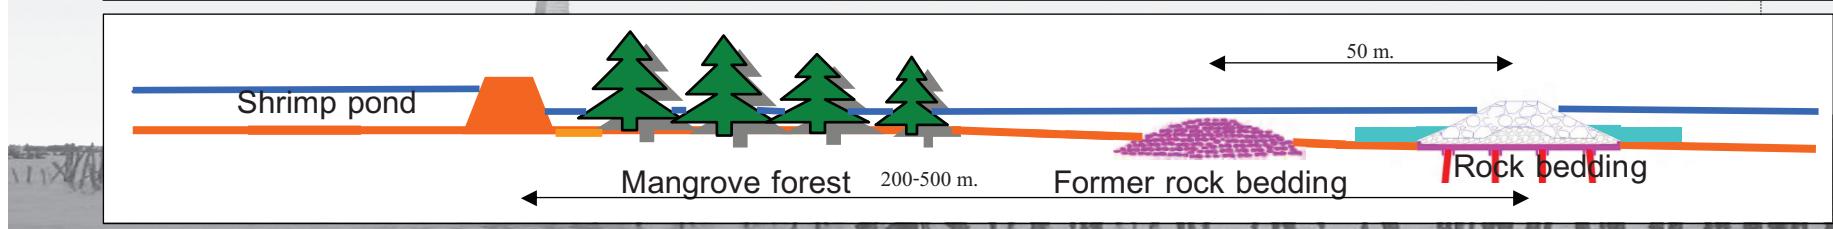
The adjusted model of T-Groin :
 From Sand bags to T-shape rock bedding with an interval of 500 meters on reinforced concrete cement, and another outer line of 300-meter rock bedding.

1. The landowners were consent that the BMA modify the T-Groin construction from sand bags to rock bedding to avoid the rupture of the sand bags that might be harmful to the area ecosystem and way of local lives.
2. As a temporary measure, BMA should prevent the coastal erosion with the utilization of bamboo sticks to prevent any damages occurring during the construction of the rock bedding.

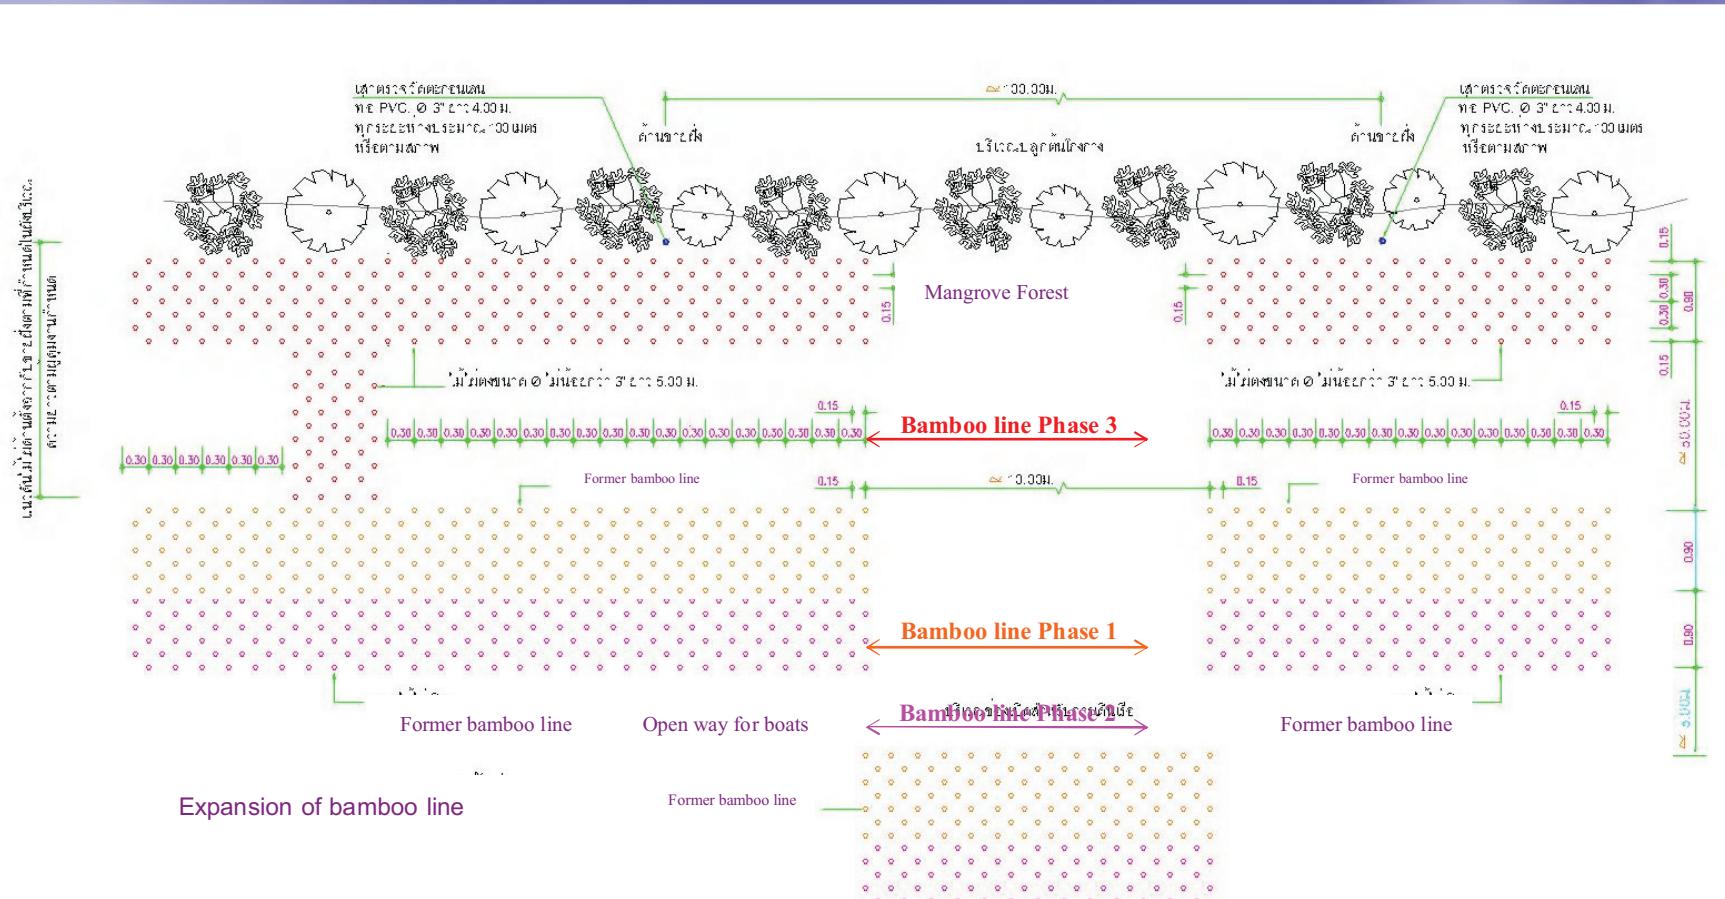
Bamboo construction plan : to protect Bang Khun Tien Coastal Erosion

Phase 1 : Completed in March 2011.

Phase 2 : Under construction, to be completed by December 2011

Phase 3 : Budget approved, to start construction in December 2011

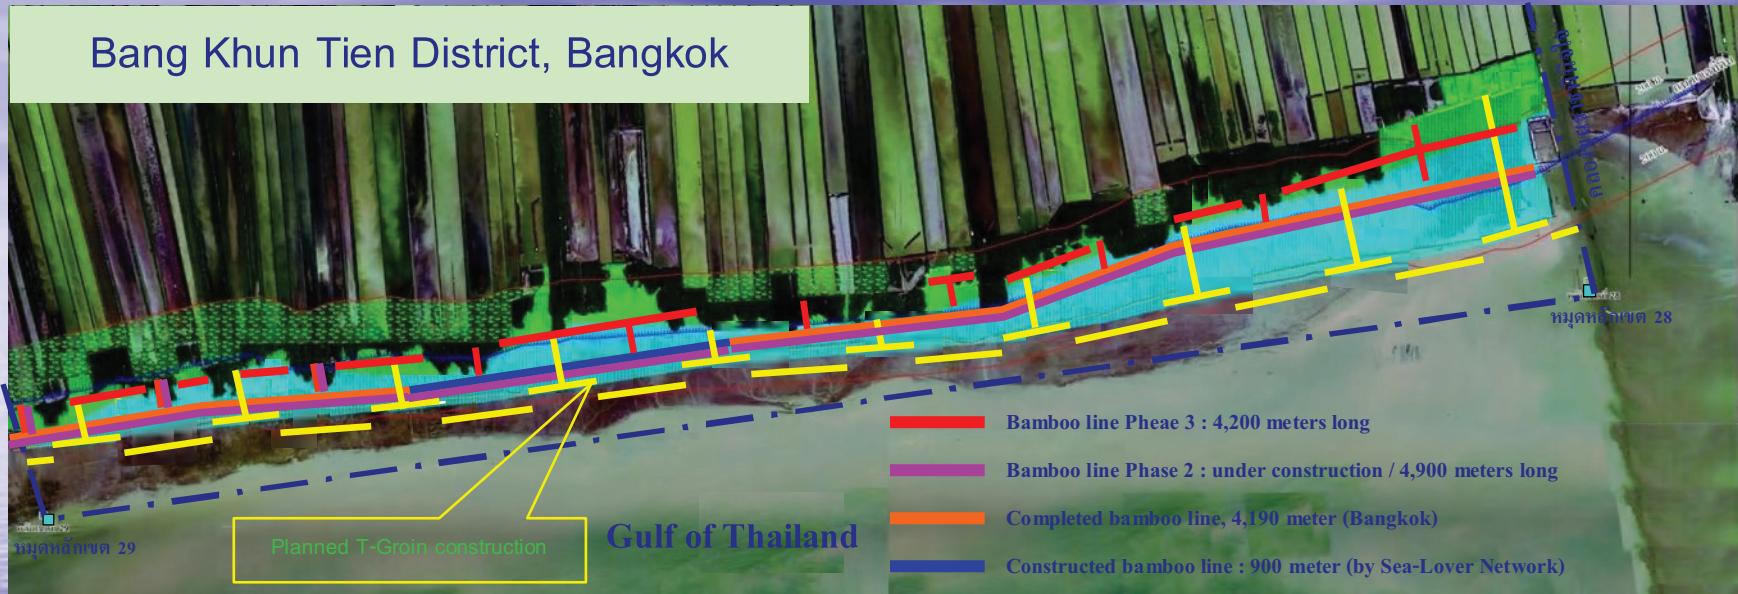
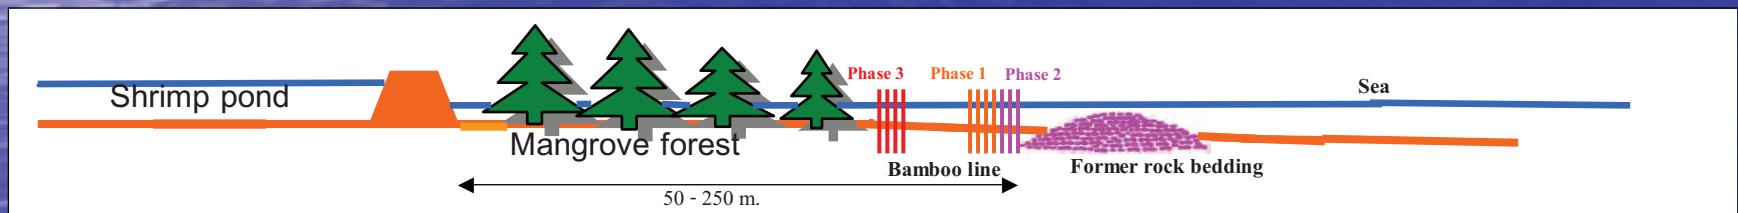
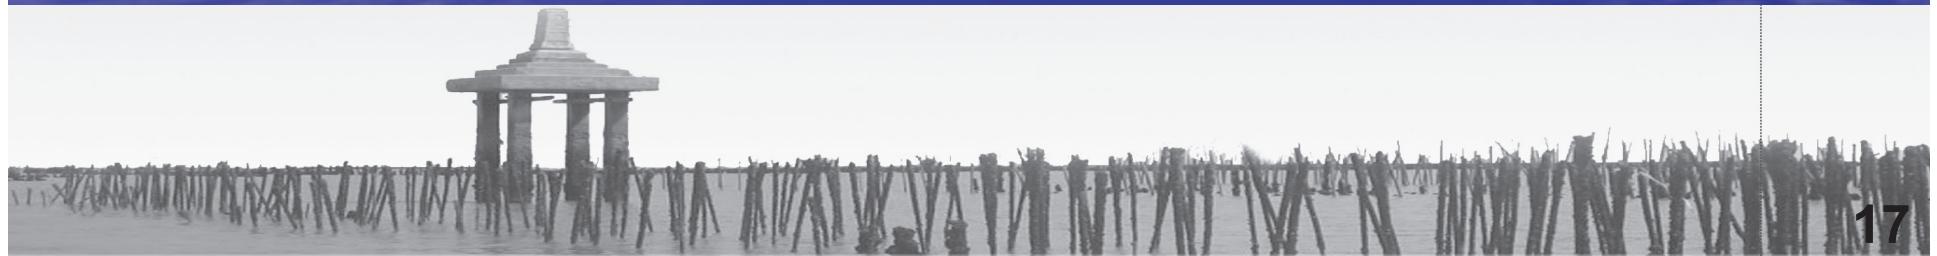
Bamboo construction plan to protect coastal erosion

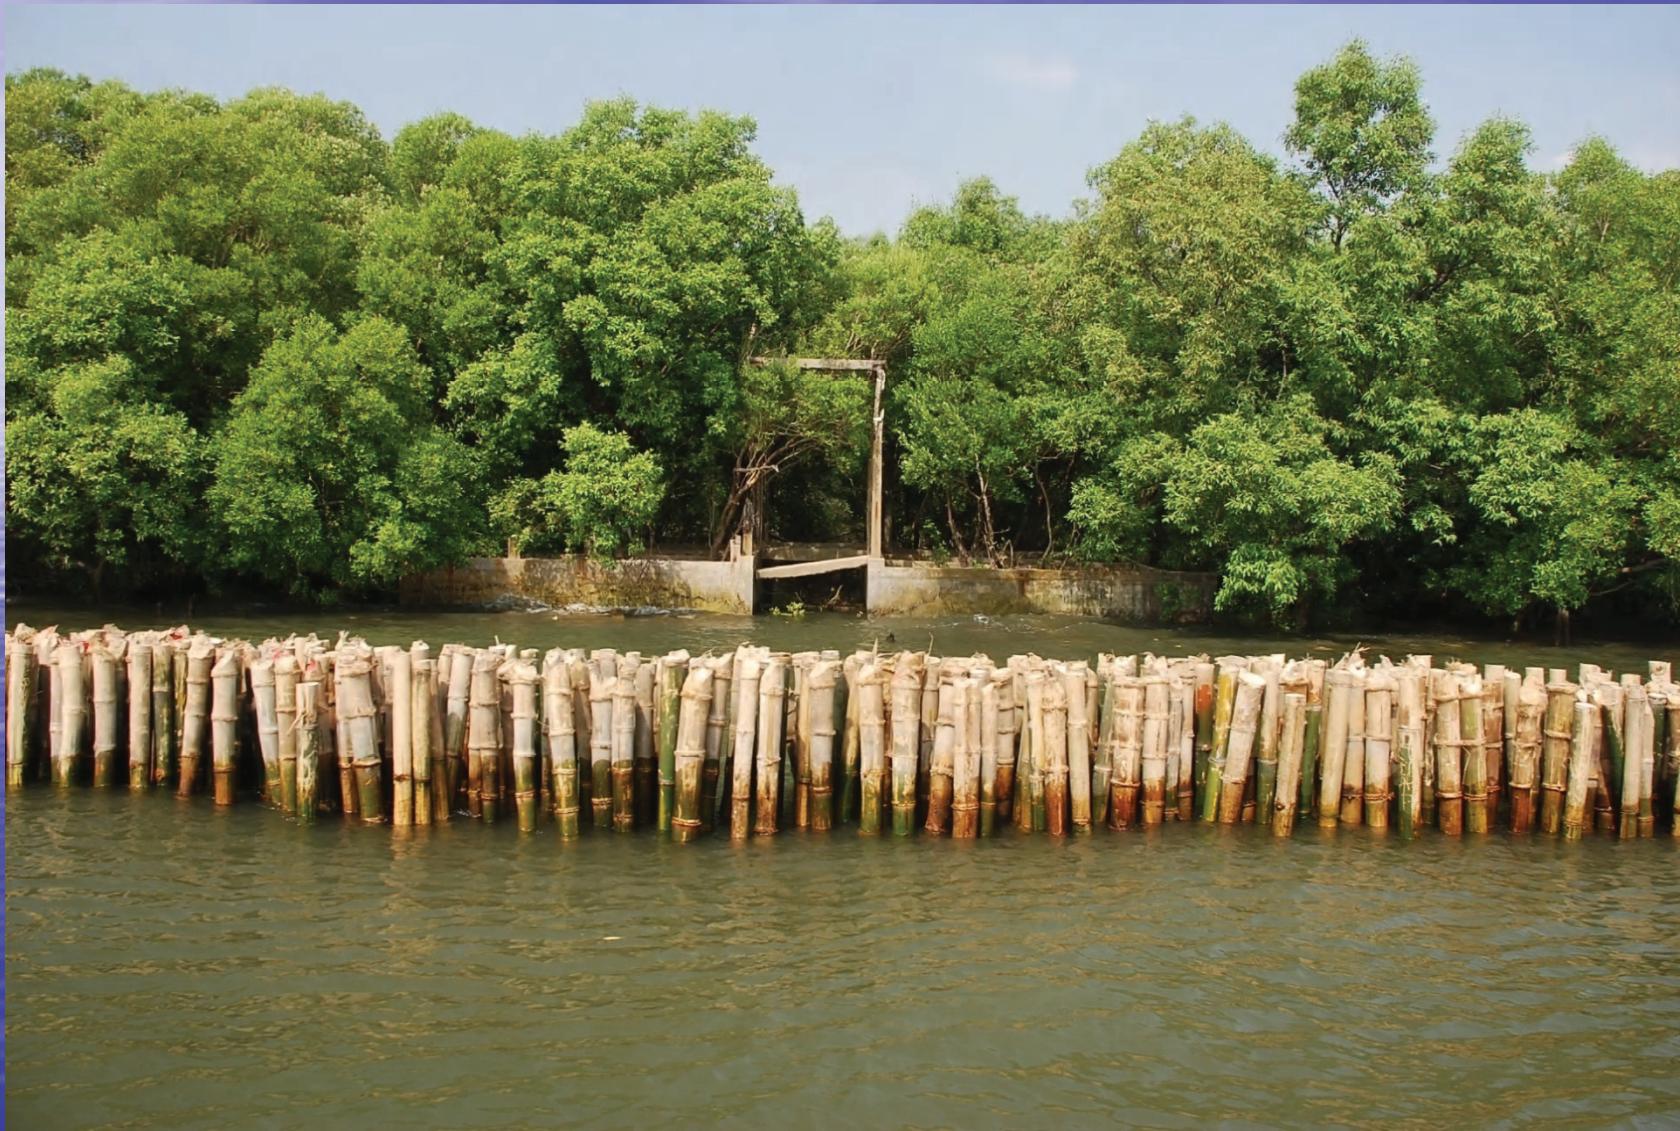
The finishing of bamboo piling to protect Bang Khun Tien coastal erosion.
